**MONITORING AND INVESTIGATION OF A MULTI-SUITE
RESIDENTIAL COMPLEX IN WHITEHORSE, YUKON,
FROM 1988 To 1992**

**Efficiency and Alternative Energy Technology Branch, CANMET
Energy, Mines and Resources Canada
Ottawa, Ontario
March 15, 1993**

**Howell-Mayhew Engineering Inc.
15006-103 Avenue
Edmonton, Alberta
T5P 0N8
(403) 484-0476**

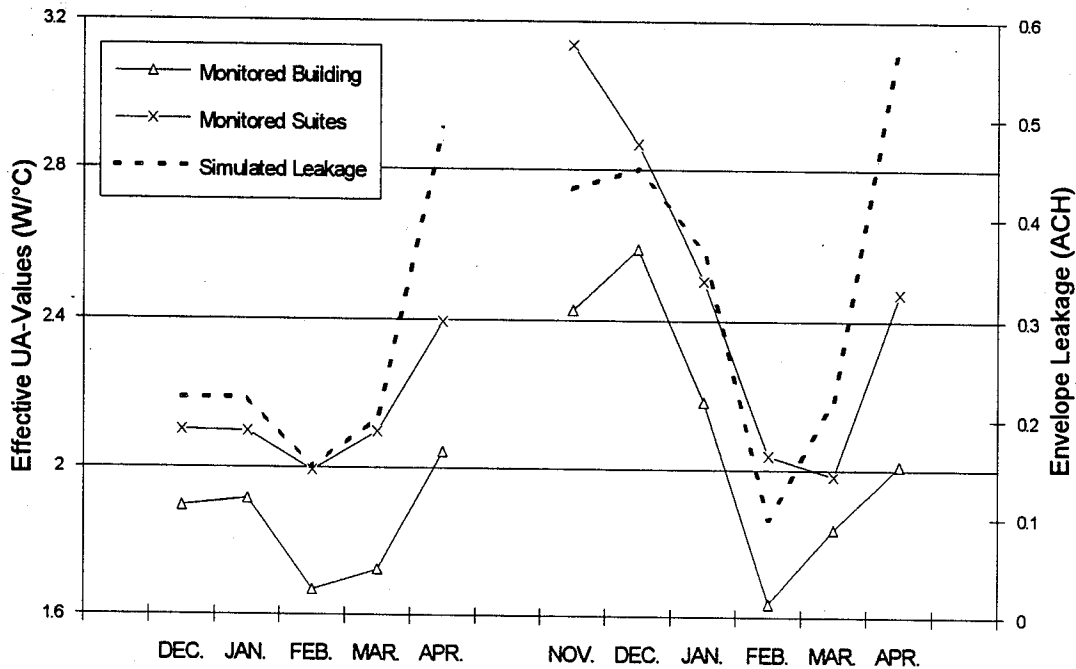
Figure 10: Effective UA-Values and Envelope Leakage

The DOE simulation work indicated that, with the advanced R-2000 envelope air barrier system, the building had the capability of achieving an uncontrolled leakage rate of 0.1 ACH². The rate that was typically achieved at Closeleigh Manor, however, appeared to vary significantly from 0.1 ACH and, at times, there was as much outside air leaking across the envelope as there was being supplied by the central ventilation system. From Figure 10, it can be seen that the variations caused notable increases in space heating requirements. For example, November and February 1992 had HDD of 816 and 860 respectively. The space heating required in November, however, with a simulated envelope leakage rate of 0.43 ACH, was 122.5 GJ compared to 77.7 GJ, an increase of 58%.

In order to verify that the DOE simulated leakage rates were correct, monitored data from the individual suites was analysed to determine if the space heating requirements in the suites varied with changes in the simulated air leakage rates, which had been determined using monitored data for the entire building. The analysis was conducted by comparing variations in the effective UA-values³ of the monitored suites with the variations in the building's leakage rate. The results of this comparison, which are presented in Figure 10, showed a strong relationship between the envelope air leakage rate and the space heating requirement and confirmed that the simulated rates were a clear indication of the actual leakage rate which was occurring in the building.

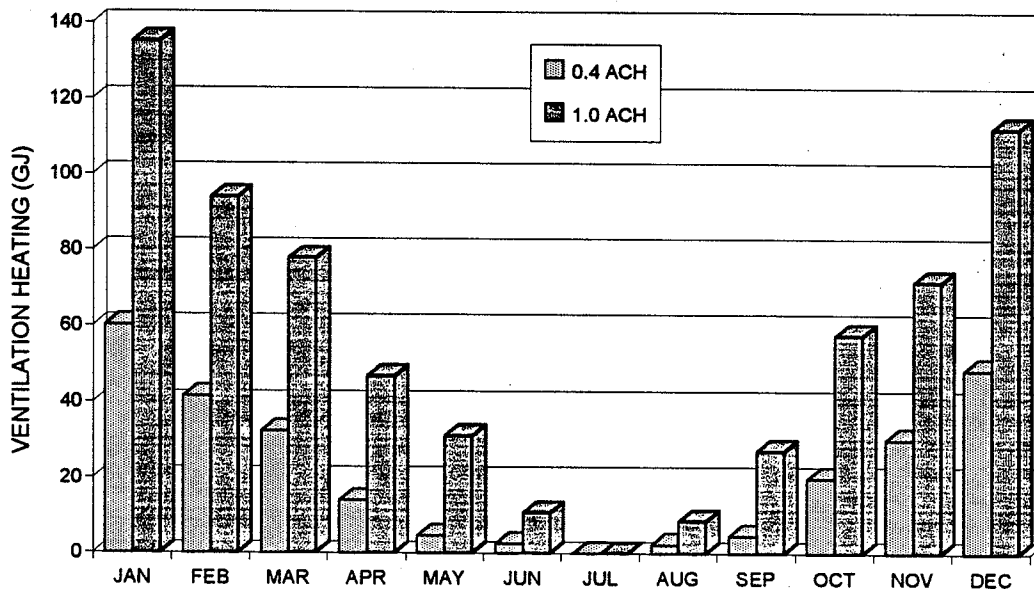
Figure 15: Effect of Reduced Ventilation Rate on Ventilation Heating

current operating value of 0.4 ACH. The values shown assume an overall heat recovery efficiency of 40%. By reducing the ventilation rate to 0.4 ACH, the ventilation heating requirement was reduced 64% to 246 GJ. The overall energy consumption would be reduced 25% to 1311 GJ.

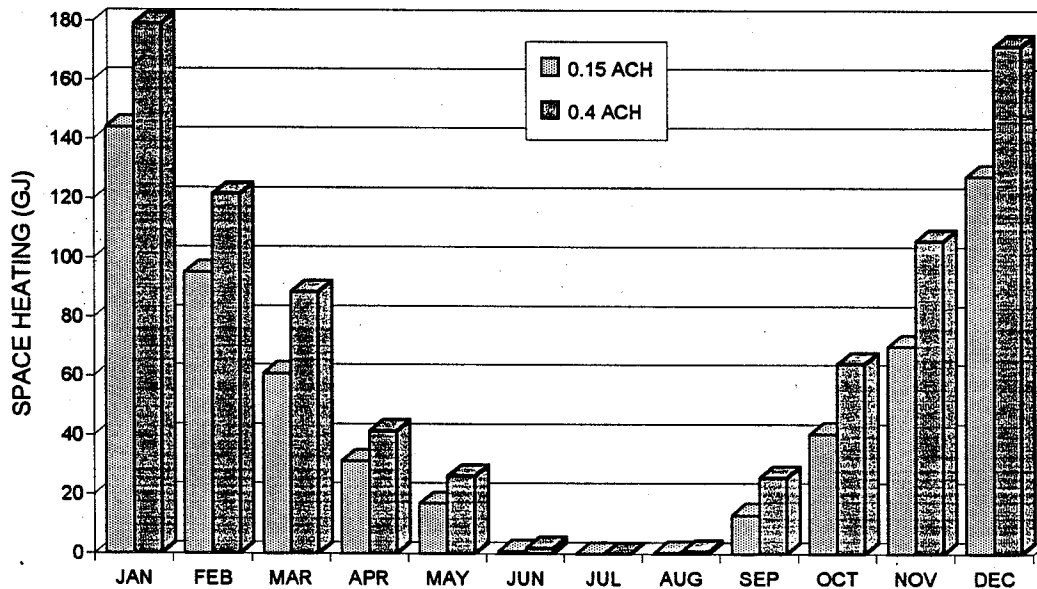
Figure 16: Effect of Reduced Envelope Leakage on Space Heating

The continuous air barrier system installed as part of the R-2000 enhancements, provided the building envelope with a potential for reducing uncontrolled envelope air leakage to as low as 0.1 ACH. The controlled envelope leakage rate is primarily affected by occupants opening windows and, as indicated in Section 3.3.3, has a significant impact on space heating. Figure 16 shows the space heating requirement for the building with a controlled leakage rate of 0.4 ACH and 0.15 ACH.

The DOE model, which assumes a wind speed of 16 km/h, predicted that the space heating requirement for a TMY would be reduced 28% to 601 GJ and the overall energy consumption reduced 17% if the controlled leakage was reduced to 0.15 ACH.

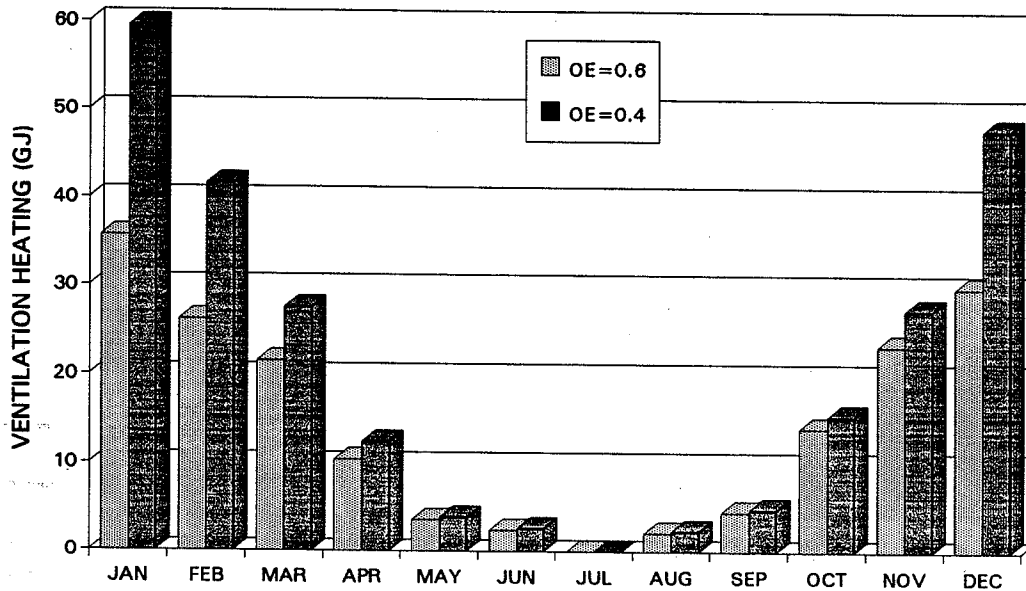
Figure 17: Effect of Improved Heat Recovery on Ventilation Heating

Figure 17 shows the energy requirements for a building with a heat recovery system having an overall effectiveness of 40%, and for one with an effectiveness of 60%, and assumes a ventilation rate of 0.4 ACH and an envelope air leakage rate of 0.15 ACH.

The DOE model predicted that the ventilation heating requirement for a TMY would be reduced 29% to 174 GJ if the heat recovery system had an overall effectiveness of 60%. The overall energy consumption would be reduced an additional 7%.

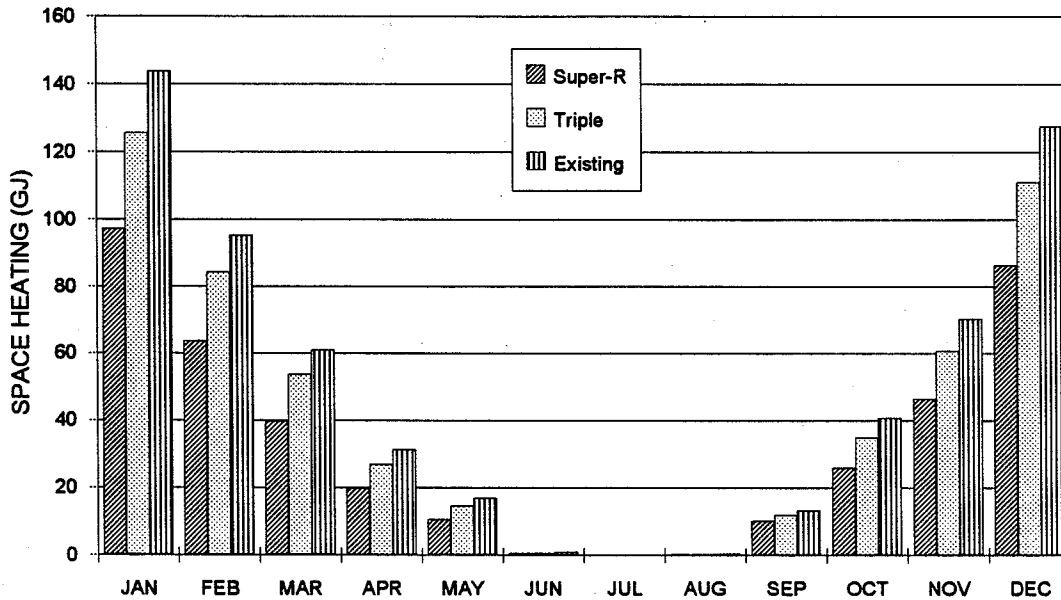
Figure 18: Effect of Upgraded Windows on Space Heating

Windows have typically been the "holes" in the building envelope because of their relatively low thermal resistance. Window technology has advanced significantly in recent years, however, and high performance windows are now available for which resistance values of RSI 1.4 are being reported. Figure 18 shows the space heating requirements for Closeleigh Manor with the existing windows, with triple-glazed windows and with high performance window technology (Super-R).

The DOE model predicted that the space heating requirement for a TMY would be reduced 13% if triple-glazing was used throughout the building and by 33% if high performance window technology (RSI 1.4) was used.
